# Bladerider – Trouble Shooting

Last Update - July 1, 2009

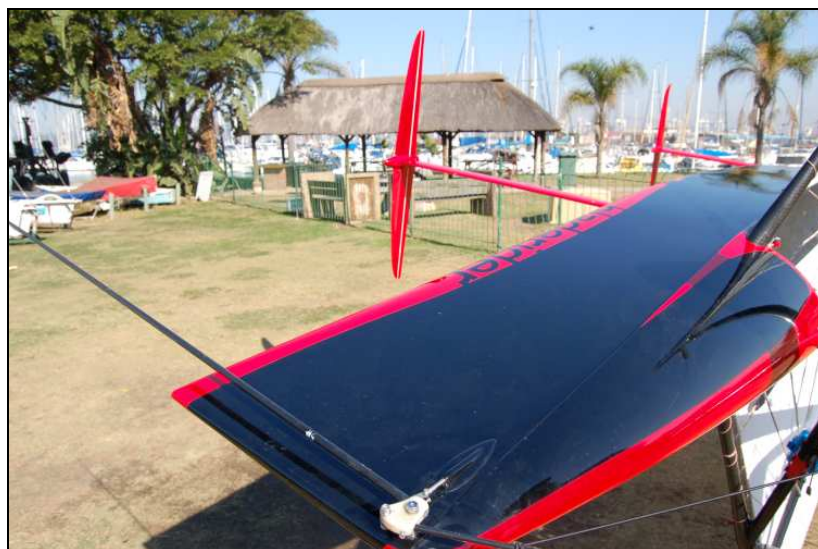
If there is little or no resistance in the wand linkages, then push the wand as far forward as possible. The wand should be perpendicular (or slightly forward of perpendicular) to the bow of the boat (as per photo below), and the flap should be in the 'fully up' position.

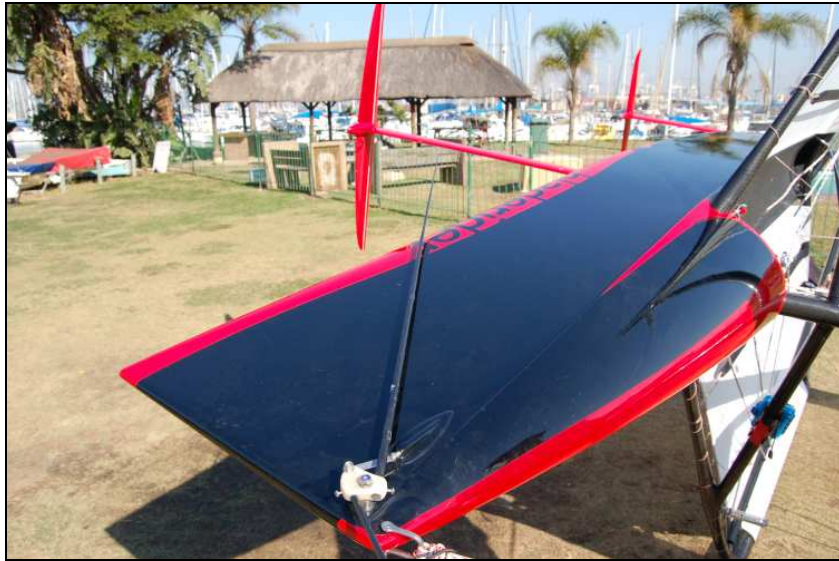
When the wand is pushed back as far as it can go (ie when the flap should be fully down), the wand should line up with the letters 'er' in the signage 'Bladerider' on the side of the hull (or be approximately 60 degrees to the bow as per photo below).

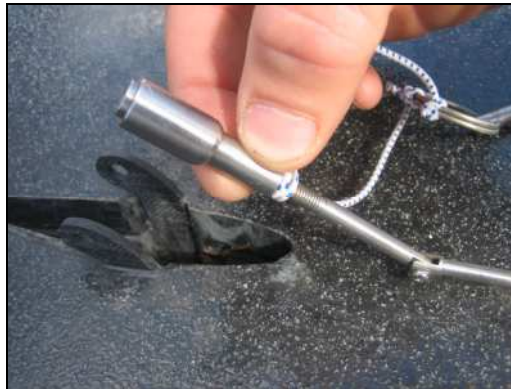
If the wand cannot be pushed back without force to the letters 'er' on the side of the hull (ie when the boat is sailed with the wand tip just under the waterline position), then there is probably too much lift on the front flap and boat will sail very high out of the water all the time. Therefore you will need screw in the socket joint head until you get the desired push-rod length and hence the correct amount of lift on the front foil flap (as per the photo below).

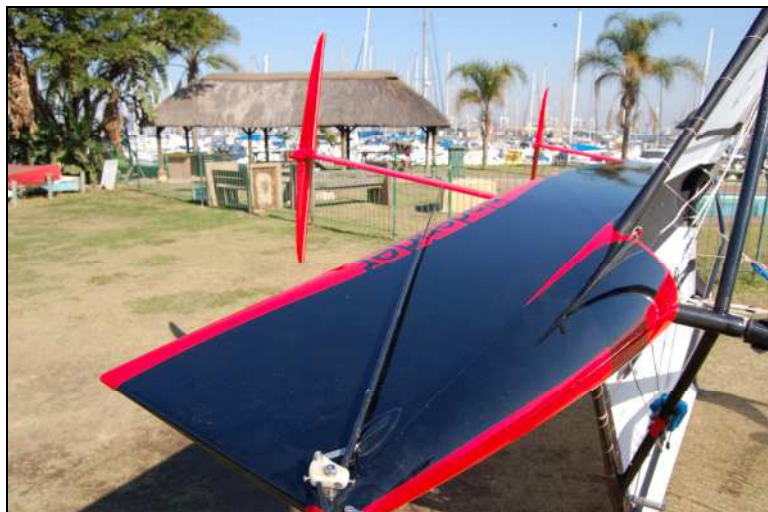
The first thing to check is if the wand can be pushed back passed the letters 'er' in the signage 'Bladerider' on the side of the hull (or be past 60 degrees to the bow as per photo below). If this is the case, then when the boat is sailing in displacement mode (low-riding and hoping to fly) with the wand at around 60-45 degrees to the bow, then the front flap is not pushed down enough and consequently does not give you enough lift to take off. Therefore you can fix this on water by simply winding out the ball/socket joint head at least two more turns at a time to give you more lift.

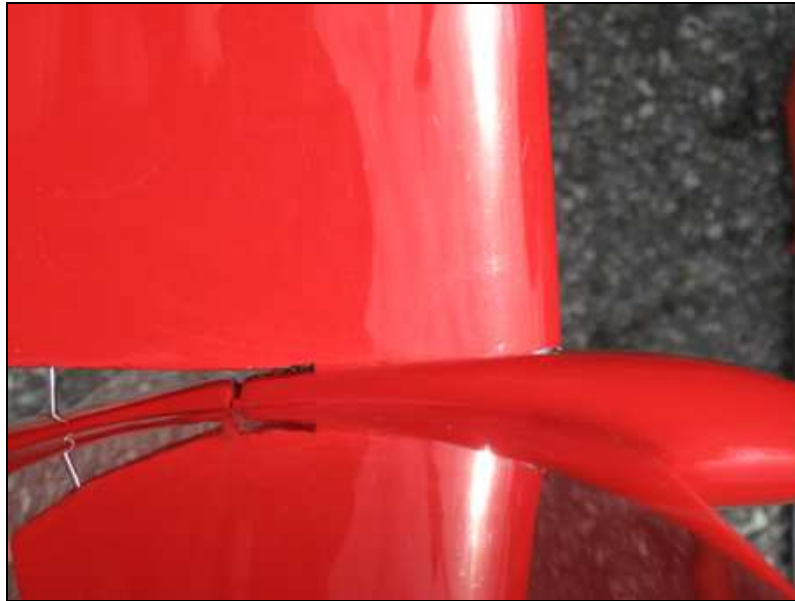
If this still does not fix the problem, then you will need check to see if the front foil is all the way onto the centerboard, as may not have been hit on hard enough when initially set up. To check this, there should only be a small 2mm gap between the back edge of the foil join and the bottom of the centerboard (as per the photo below). If not, remove the locking screw in the bottom and use a rubber mallet/hammer to hit the foil on further onto the bottom of the centerboard. Ensure that your strikes are directly forward and back of the hole on the bottom as so it works its way on slowly. This should be a very tight fit, so you may need to hit hard.

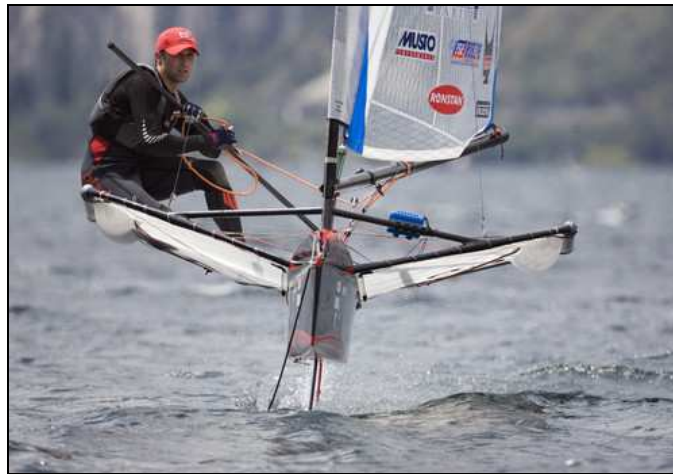
If your wand annoyingly taps on the side of the hull at low speeds or worse still the centerboard or rudder is ventilating/stalling (ie air bubbles and drag on the leeward side of the centerboard or rudder), this is due to the wand not being offset enough from the centerline of the hull.

This is because the air bubbles that the wand creates under water in the centerline, can be sucked down by either the centerboard or rudder which causes the sudden ventilation. Even if the wand is slightly offset, it only takes a small wave or turning to starboard to cause the problem. The problem is also greatly enhanced, the colder the water gets.

If this does happen to you whilst sailing, it is suggested to keep the boat as close to the water as possible and avoid too high speeds until you can get back ashore. Then unscrew the wand and rotate it so that the wand will 'ski' and bend away from the centerline of the hull once under pressure (as per photo below).

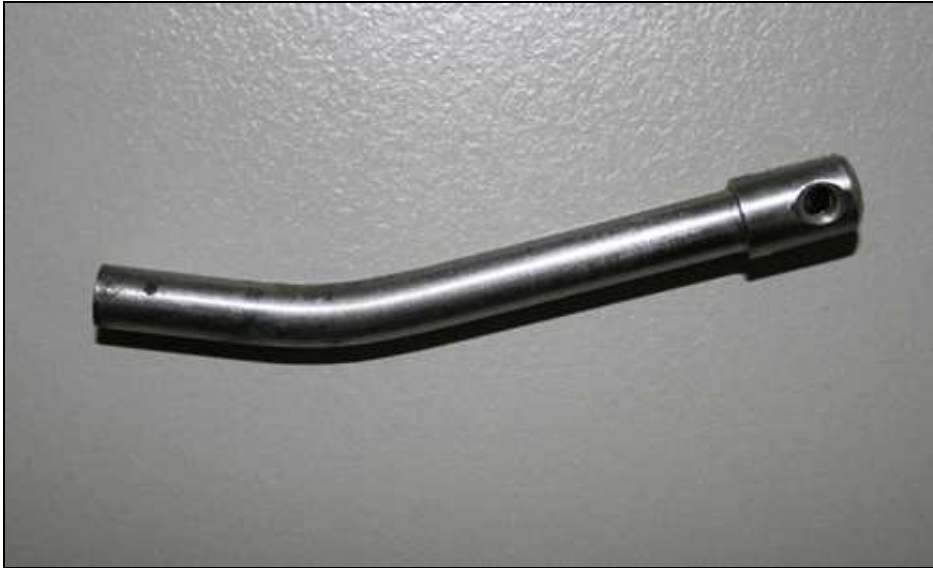
### **7.1.6 Front Push Rod Cable Slider comes out too far and bends**

If your cable slider can pull too far out of the hull and on occasions, the slider has bent upwards, then firstly check that the amount of travel or the amount the push rod can slide back and forth is no more than 30mm. If it can travel more than this amount, it means that they can extend too far out of the hull and bend due to the exit hole in the cockpit or near the bow being too short. Therefore you will need to shorten the push rod inside the hull by an amount so that it cannot travel more than 30mm. A replacement hull push rod may not help as it will be same length as the one that you have already, however it is important that you first check that the cable sliders are wound all the way onto the push rod, otherwise if they are wound out, they will make the overall length longer and cause problems.

You should also need to check the exact position of the push rod exit hole compared to the wand axle. It should be 67mm away from the end of the hull push rod exit hole and a minimum of 14 and maximum of 19mm above it. Any variation of these measurements will also not help. A drawing of this position can be downloaded from [www.bladerider.com.au/support/wand\\_positioning.pdf](http://www.bladerider.com.au/support/wand_positioning.pdf).

If your wand position is more than a 2mm from the above drawing, it is recommended that you follow the "Wand Axle Replacement" instructions that can be downloaded from [www.bladerider.com.au/support/wand\\_axle\\_replacement.pdf](http://www.bladerider.com.au/support/wand_axle_replacement.pdf), to move the wand axle into the correct position.

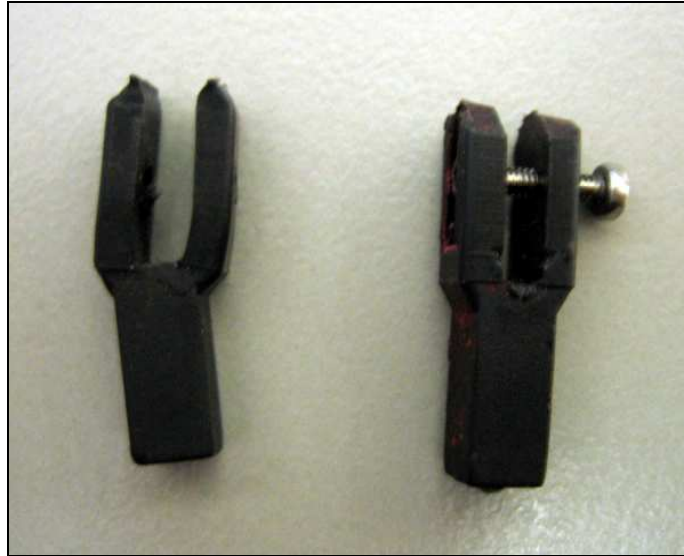
### **7.1.8 Upper Control Rod Connector is Deforming**

Under a lot of load, the original Bladerider plastic Upper Control Rod Connectors in the centerboard can deform, and give 'spring' in the push rod system. It is important to keep an eye on these, however you can make your own using some nylon 'chopping board' (or Teflon), a hacksaw, a 1.5mm drill bit and a 2mm tap. The idea is to cut a piece of nylon approx 25mm x 10mm x 7mm. Then cut an 8mm slot in the top to form the gate for the Bell Crank Axle. Then drill a 1.5mm straight hole in the top for the 2mm axle bolt, and another hole in the bottom for the push rod. Use a 2mm tap, to make the thread. See some home made examples below.

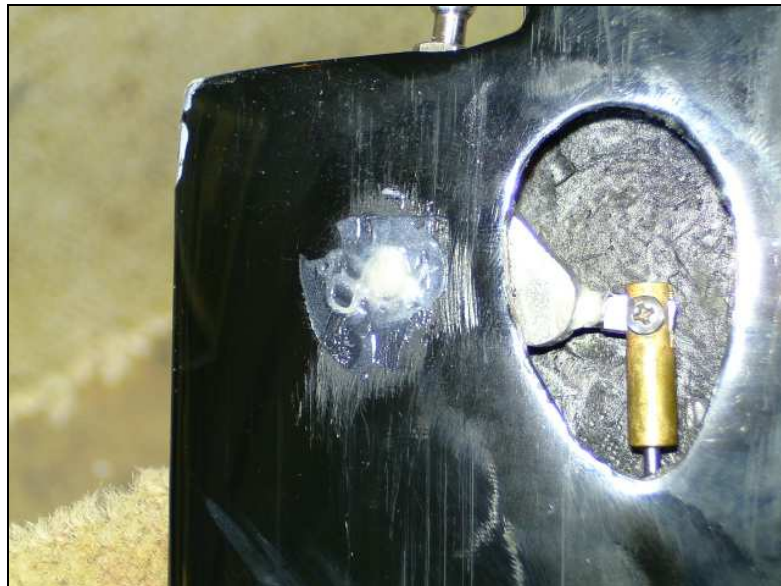
## **7.1.10 Bell Crank Axle is Loose in Centerboard**

If the stainless steel axle at the top of the centerboard for the Bell Crank is unwinding itself when sailing or is loose inside the hole, then you will urgently need to glue in the axle on both sides to the centerboard, using ONLY epoxy glue with filler additive (only use 5 minute epoxy in emergencies).

Once the glue is set hard (after 24 hours), you will need to file/sand off any excess glue that will prevent the centerboard from being inserted into the centerboard case. There should no need to remove this axle in the future once your setup is correct, however it will be possible to cut it out if necessary.

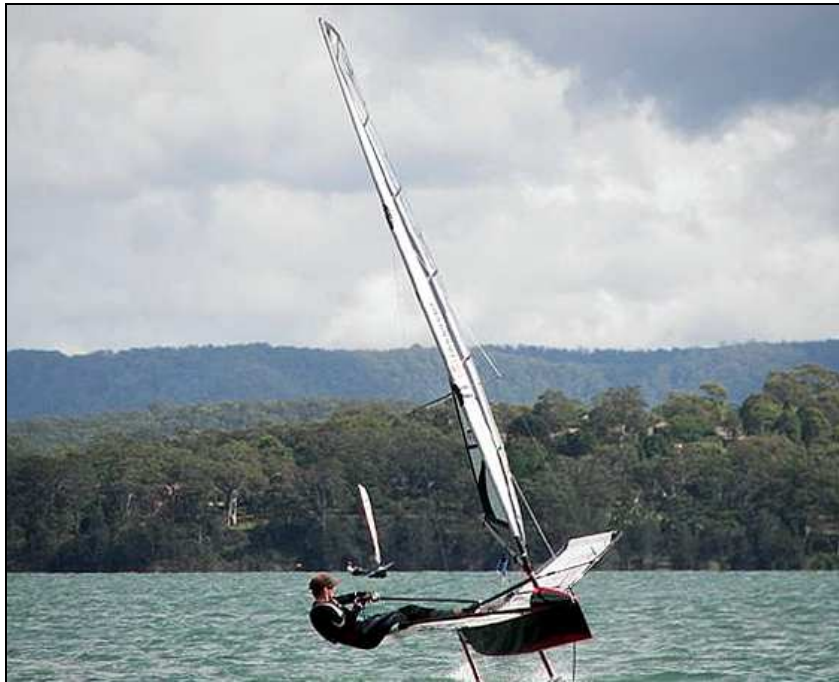
When sailing upwind in light/moderate conditions, the bow should only be angled about 1-3 degrees up and the wand should be angled approximately 30 degrees perpendicular to the bow so that the front foil flap is neutral for the best efficiency.

In high winds, the hull should virtually be parallel to the water surface, and in order to do this, you may have to add lift onto the rudder foil to push the bow down and move forward to see the boat accelerate.
